**Docket No. 217 – Development and Management Plan Inspection**

**Date:** August 3, 2006

**Location:** Transition Stations: Hoyts Hill, Archers Lane, Norwalk Junction

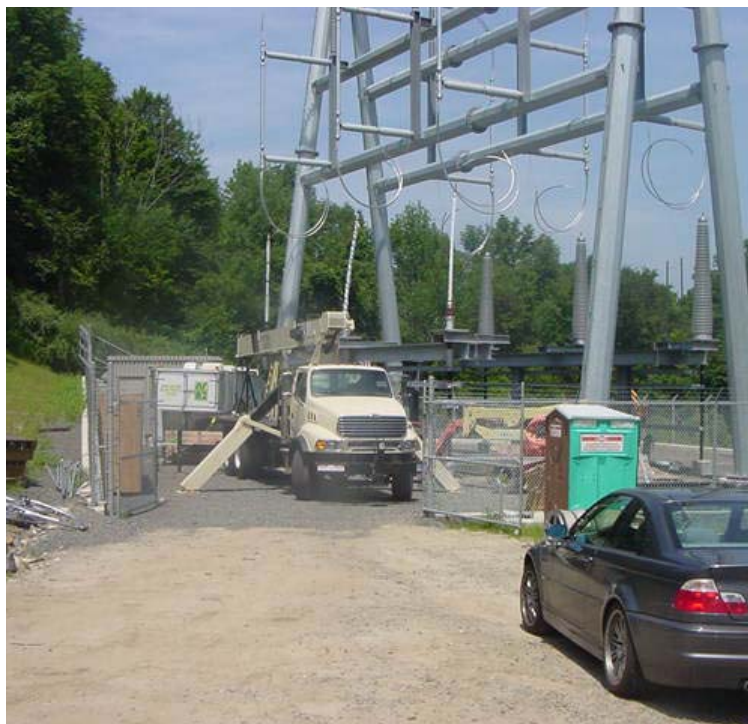
Hoyts Hill Transition Station: Photo on the left shows a view of the electrical work at the station pad. Photo on the right shows the silt fence in place along the edge of the wetlands. 8/3/06

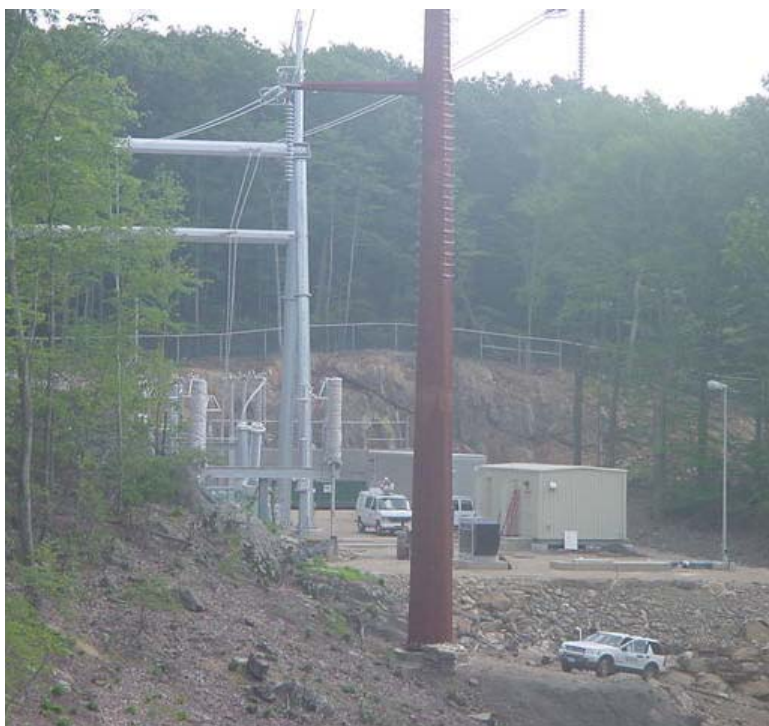
Archers Lane: Photo on the left shows the entrance off Diamond Hill Rd. Trench plates were in place and haybales had been added to the stone wall where water had been pooling. Photo on the right shows an overview of the work and structures in the station yard. 8/3/06.

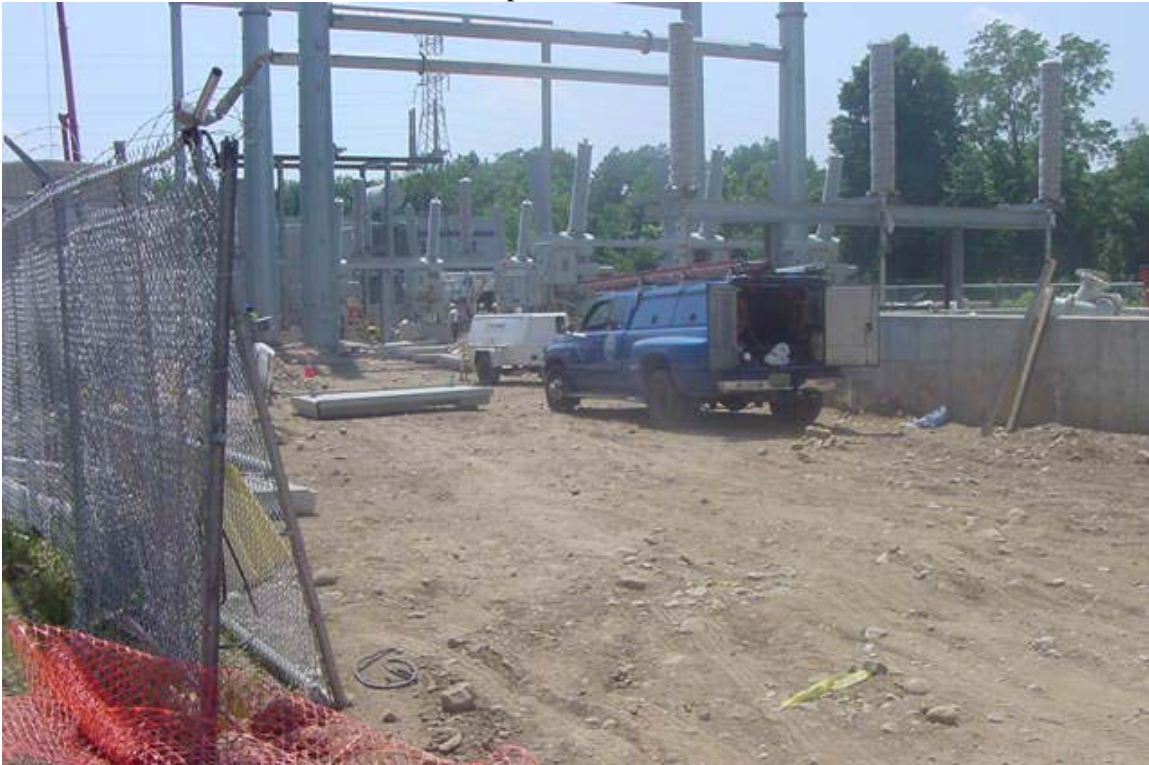
Photo shows an overview of the ongoing work in the station yard. 8/3/06.
